Re: Clean Water Act Pretreatment Inspection

Enclosed is the report for our August 15, 2018 Pretreatment inspection of the Pacific Seafood facility at the above address in Eureka, CA.

**Region 9 Enforcement Division**  
**75 Hawthorne Street**  
**San Francisco, CA 94105**  
**INSPECTION REPORT**

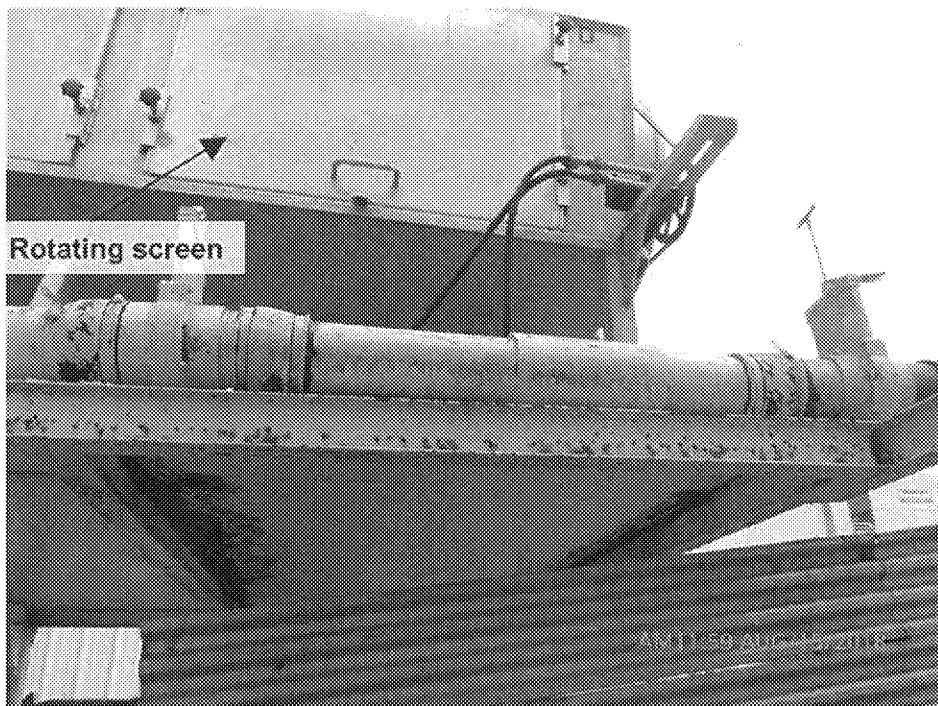
The inspection team then proceeded to the facility's pretreatment building. Wastewater from the shrimp process is sent to the hydroscreen (Photographs 9 and 10) to separate the shells and other solids from the wastewater. From the hydroscreen, wastewater gravity flows into the pretreatment building to the approximately 800-gallon initial holding tank (Photograph 29). From the initial holding tank, wastewater is pumped to one of two 10,000-gallon equalization tanks (wastewater is in equilibrium in both tanks). When the equalization tanks are approximately one-third to one-half full, wastewater is pumped into the recirculation and mixing tank where coagulant is added. Flocculent is added as the wastewater is pumped from the recirculation and mixing tank to the dissolved air flotation (DAF) unit. Solids from the DAF are pumped to the filter press. Filtrate from the filter press is pumped back to the DAF and the solids are hauled to a landfill. Effluent from the DAF is discharged to the City sewer. The inspection team observed a drum of used oil in the pretreatment building, adjacent to the building's east door (Photographs 30 and 31). Refer to Item 11 in the *Areas of Concern* section of this report for additional information.

**Photograph 8.** View of the bottom of the hydroscreen that separates wastewater from the shrimp shells.

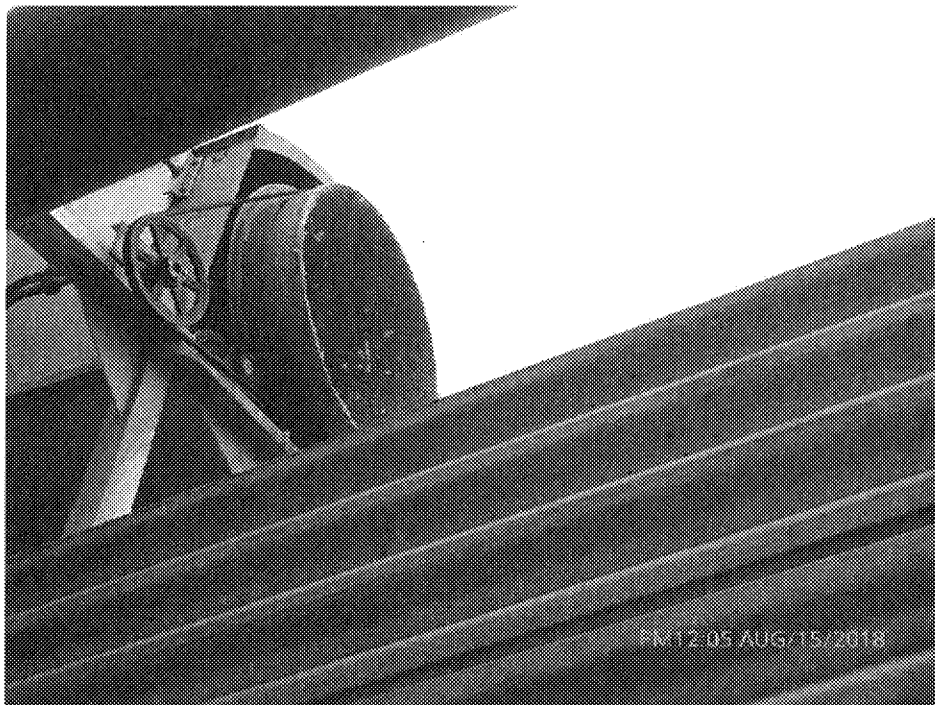
**Photograph 9.** A close-up view of the hydroscreen, shown in Photograph 8, that separates wastewater from the shrimp shells.

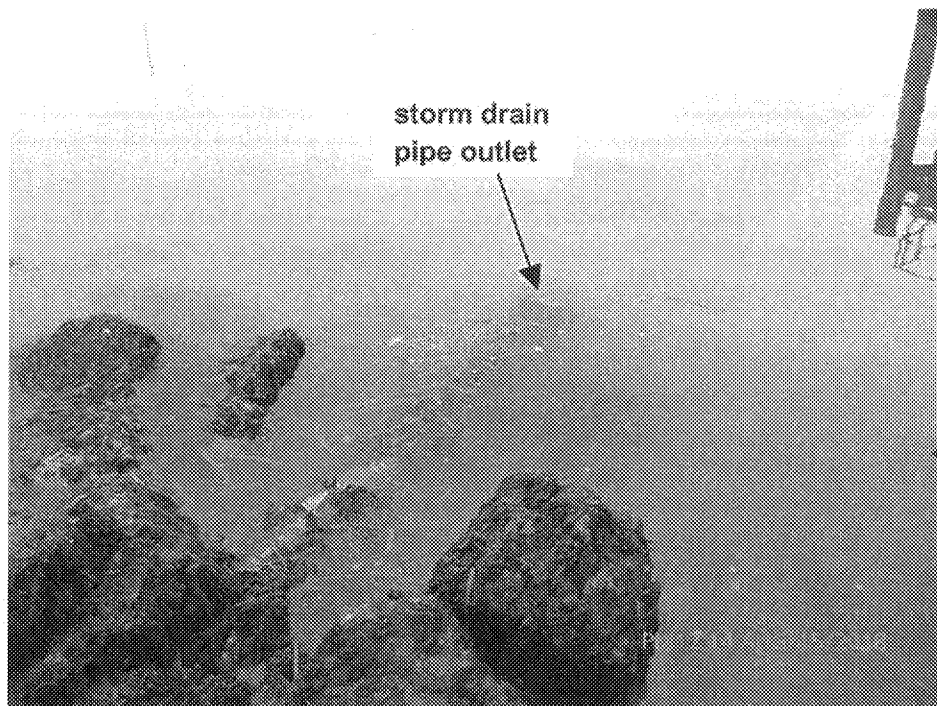
4. Adjacent to the pretreatment building, the facility loads shrimp shells onto a truck to be hauled offsite. Wastewater from the de-shelling process was observed entering a storm drain between the truck and the pretreatment building (Photographs 10 and 11). The grate on the storm drain had been removed and a screen to capture solids was situated over the storm drain. Subsection 54.040.A of the City of Eureka's Stormwater Ordinance (Ordinance No. 705 -C.S) states "No person shall discharge or cause to be discharged into the storm drainage facilities or watercourses any materials, including but not limited to pollutants or waters containing any pollutants that cause or contribute to a violation of applicable water quality standards, other than storm water." Discharge of the shrimp process wastewater to the storm drain is an unpermitted discharge.

**Photograph 14.** Close-up view of the outlet from the storm drain shown in Photographs 10 and 11.

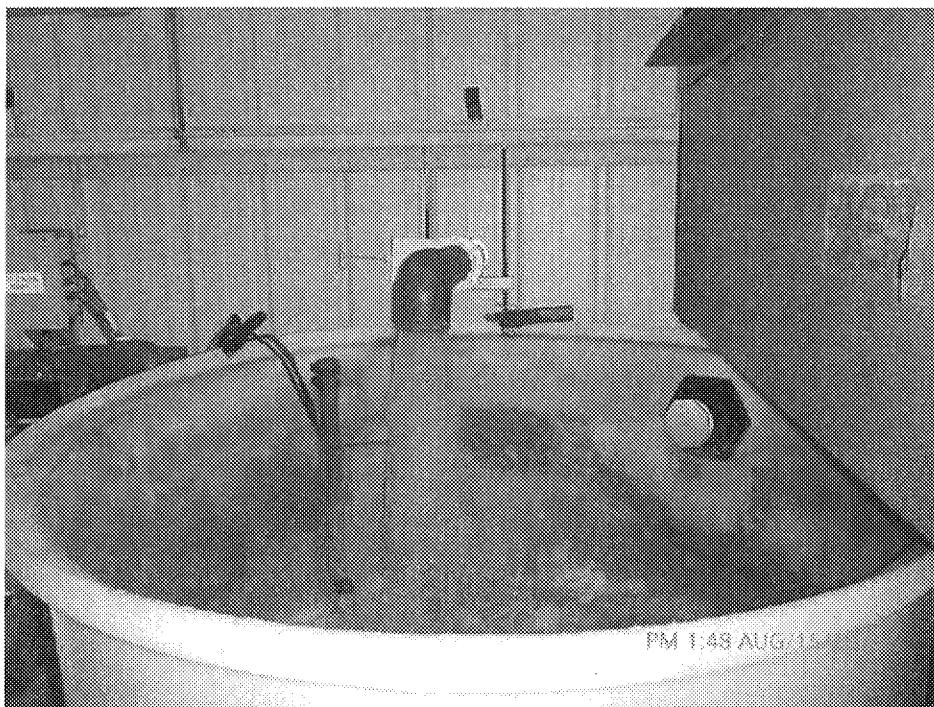
**Photograph 29.** View of the initial holding tank in the pretreatment building. Shrimp process wastewater is visible entering the holding tank.
